DAHUK REHABILITATION CENTER  
DAHUK, IRAQ

**SIGIR PA-06-070**  
**JANUARY 08, 2007**

SUBJECT: Report on Project Assessment of the Dahuk Rehabilitation Center, Dahuk,  
Iraq (Report Number SIGIR-PA-06-070)

## **Dahuk Rehabilitation Center Dahuk, Iraq**

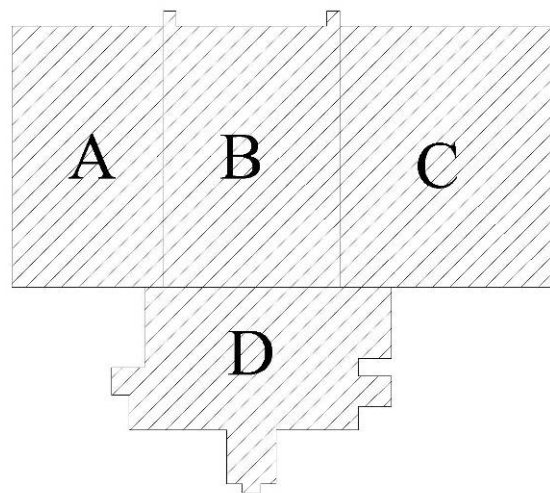
**Ground floor plan for blocks A, B, C, and D (sketch courtesy of USACE)**

Each floor of the two story facility was divided into blocks A, B, C, and D. The diagram below shows facility blocks A, B, C, and D from the contractor’s ground floor layout drawing. At the time of our assessment, the contractor had already completed repairs on the existing buildings, installation of the external walls, installation of the internal walls, and installation of waste water and rain water pipes. In addition, rough-in installation of domestic water supply system pipes for the entire building (both floors - blocks A, B, C, and D) was complete.
